**A Historical and Architectural Study of
Three Rustic Structures at Giant Forest in Sequoia National Park
The Market, District Ranger's Residence, and Comfort Station**

Prepared by
C. Craig Frazier and Craig A. Kenkel
Historical Architects

**HISTORIC STRUCTURES REPORT
SEQUOIA NATIONAL PARK**

Approved
December 7, 1988

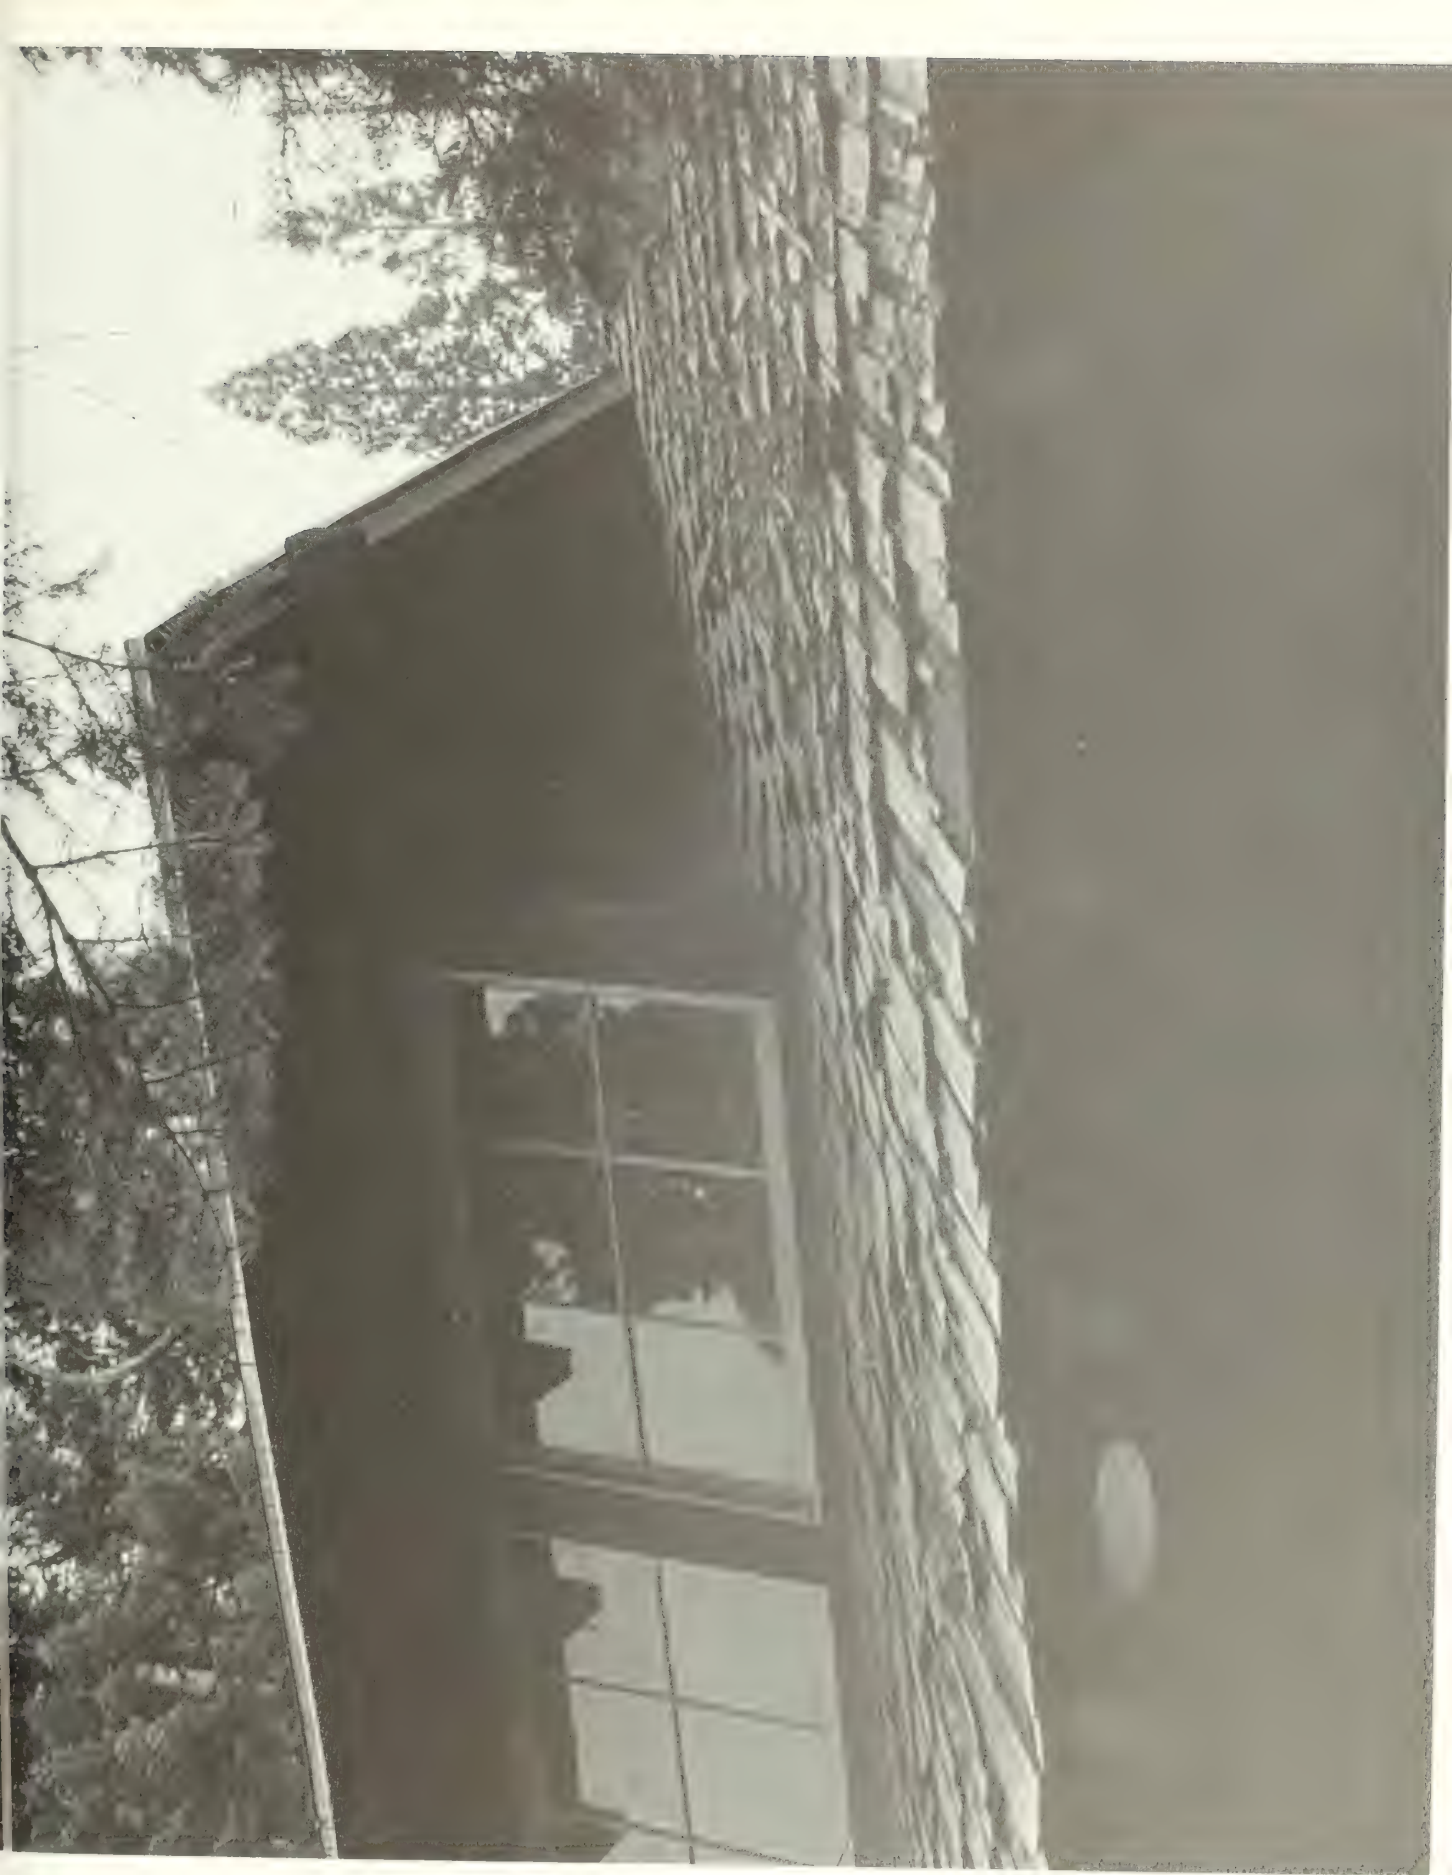
Figure 29. Market Dormer and Roof Detail (1973). The shake roof, some 44 years old at this point, is severely deteriorated. Notice edge flashing on dormer roof and roll roofing (it had no shakes), and outdoor lamp under roof eave. (Photo by Bill Jones, SEQU archive collection)

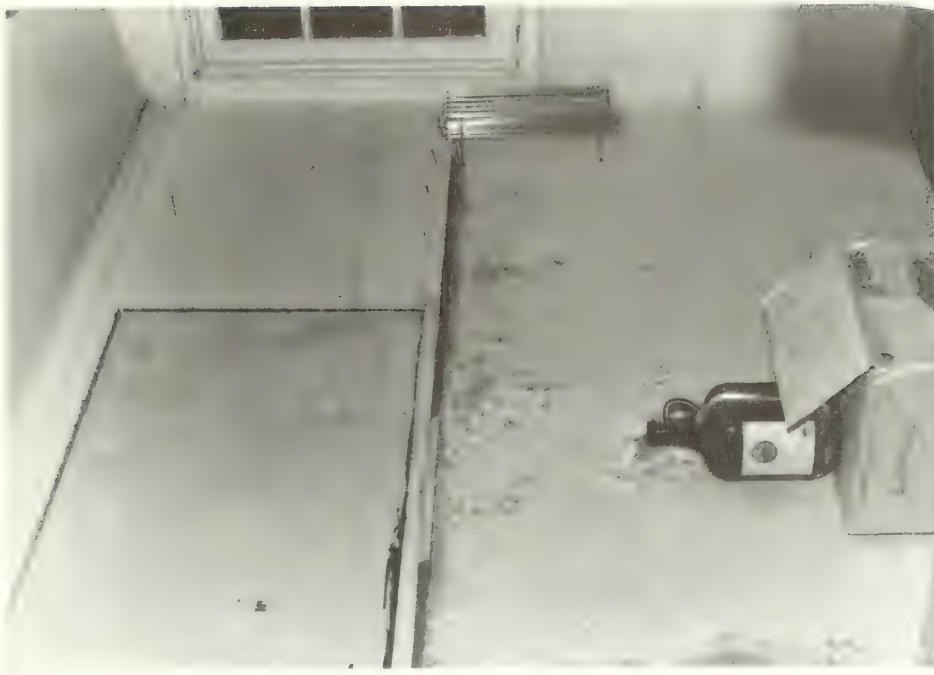
Figure 74 (right). Market - Room 112 Deficiencies (5/86). Looking towards the southeast corner, this view includes windows and ceiling covered with plywood. The paint deterioration on the concrete retaining (foundation) wall is the result of excessive moisture in the wall. The damp-proof coating on the outer side of this wall is no longer serviceable. The earth should be removed in front of this wall and new damp proof coating applied.

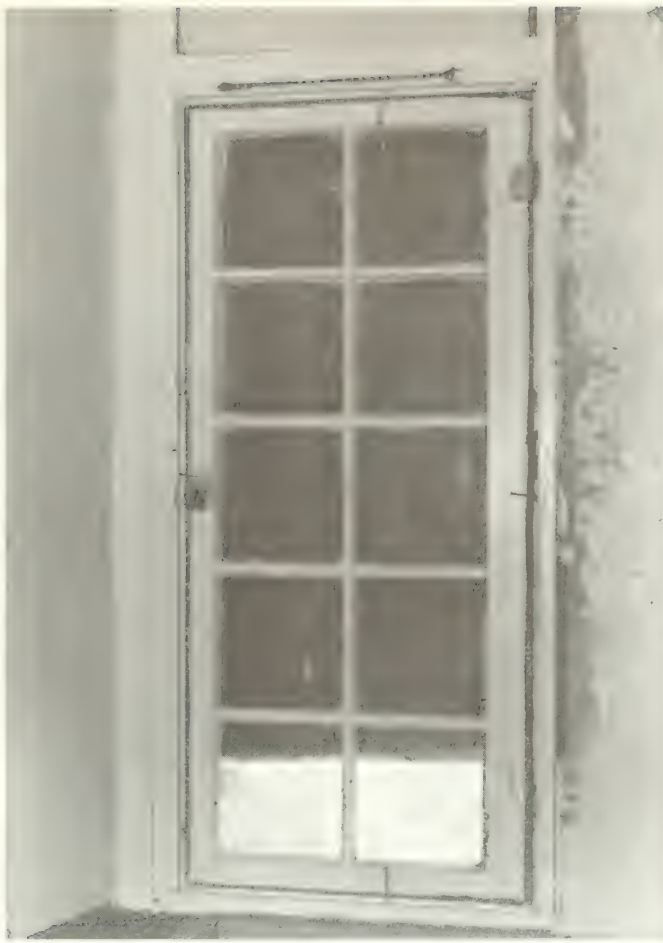
Figure 84 (right). Market Addition Window (5/86). Most of the additions' windows are 'permanently' covered with plywood and boards. This seems to be a defense against vandals and snow/moisture damage. This practice may be trapping moisture and accelerating damage. Many windows have missing or broken hardware. This window is weatherstripped tight and nailed shut and covered with plywood on the exterior. Window repairs should include refinishing sashes, reglazing where necessary and renewal of hardware including adequate security locks.

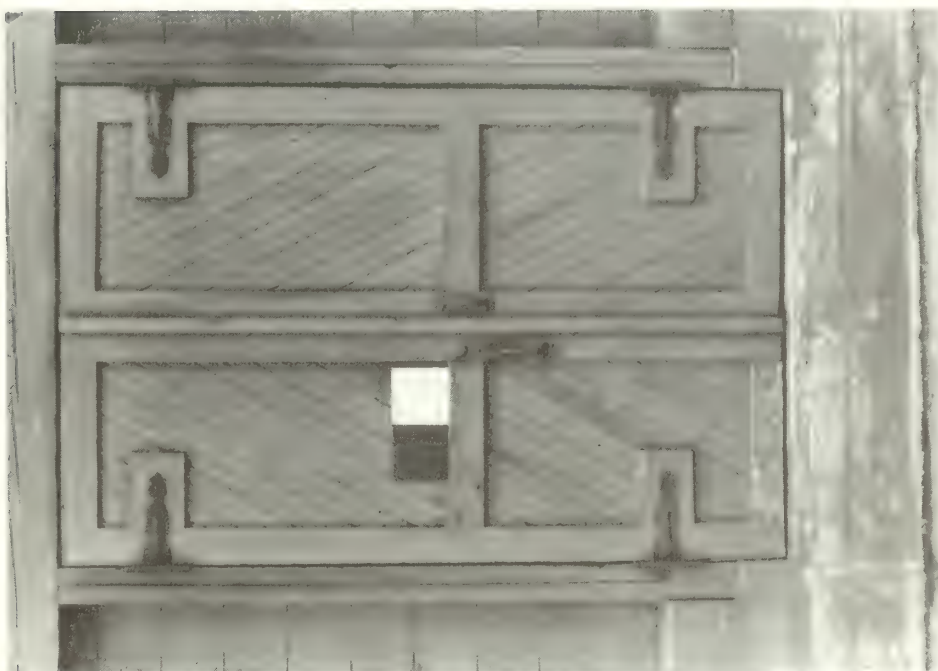
Figure 85 (left). Market Accessibility (10/86). The door sill here is about 18 inches above the walkway. This door would permit entry to room 101, but is not in use. A sizable ramping network would be necessary to make all market doors wheelchair accessible. Notice, too, mismatched door hardware.

Figure 86 (right). Market Accessibility (10/86). These steps and door stoop were installed about 1984 at the front of the north wing. They provide access to room 102 doors. Stairs such as these for visitor use would require hand railings and guard railings on the stoop. Accessibility to the south end of the building could be most easily achieved because door sills are closer to walk grade. Ramps will be necessary here.

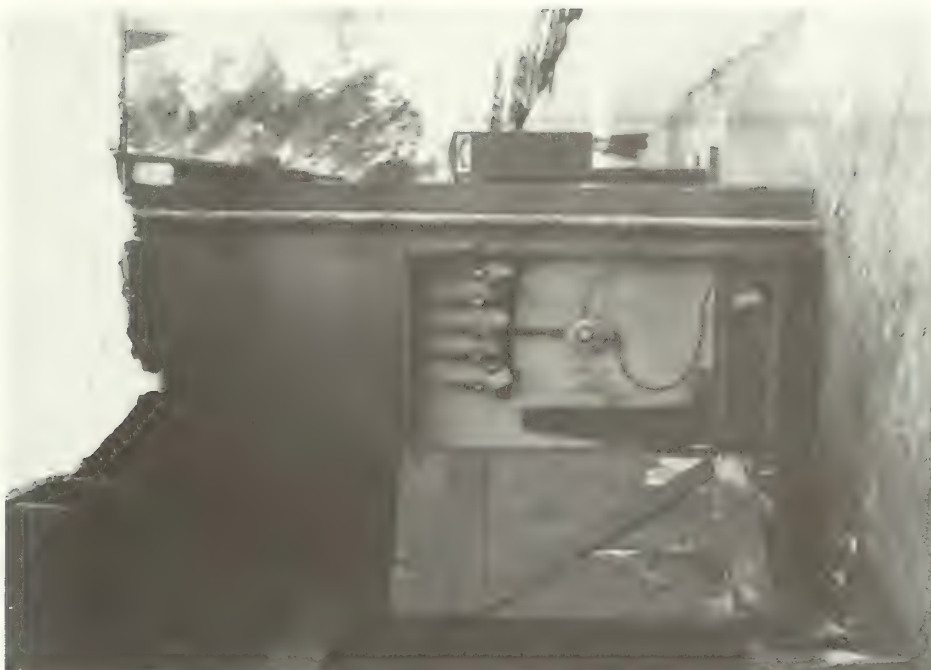
Figure 87 (left). Market Accretions (5/86). This photograph was taken at the junction of the 1938 north wing addition foundation wall (at left) and the original north wing wall (at right). Water piping is indiscreetly attached to exterior walls. The wooden box in the foreground (right) contains a water valve. Utility rehabilitation will permit elimination of these facade accretions.

Figure 88 (right). Market Accretions (5/86). This cabinet is mounted on the front of the market, it contains the main propane manifold with breakout lines to the 3 unit heaters and one hot water heater of the market and passing through the market attic and out the north side through a second valve cabinet (see figure 58) to two other buildings. When the propane system is rehabilitated, this accretion can be removed.

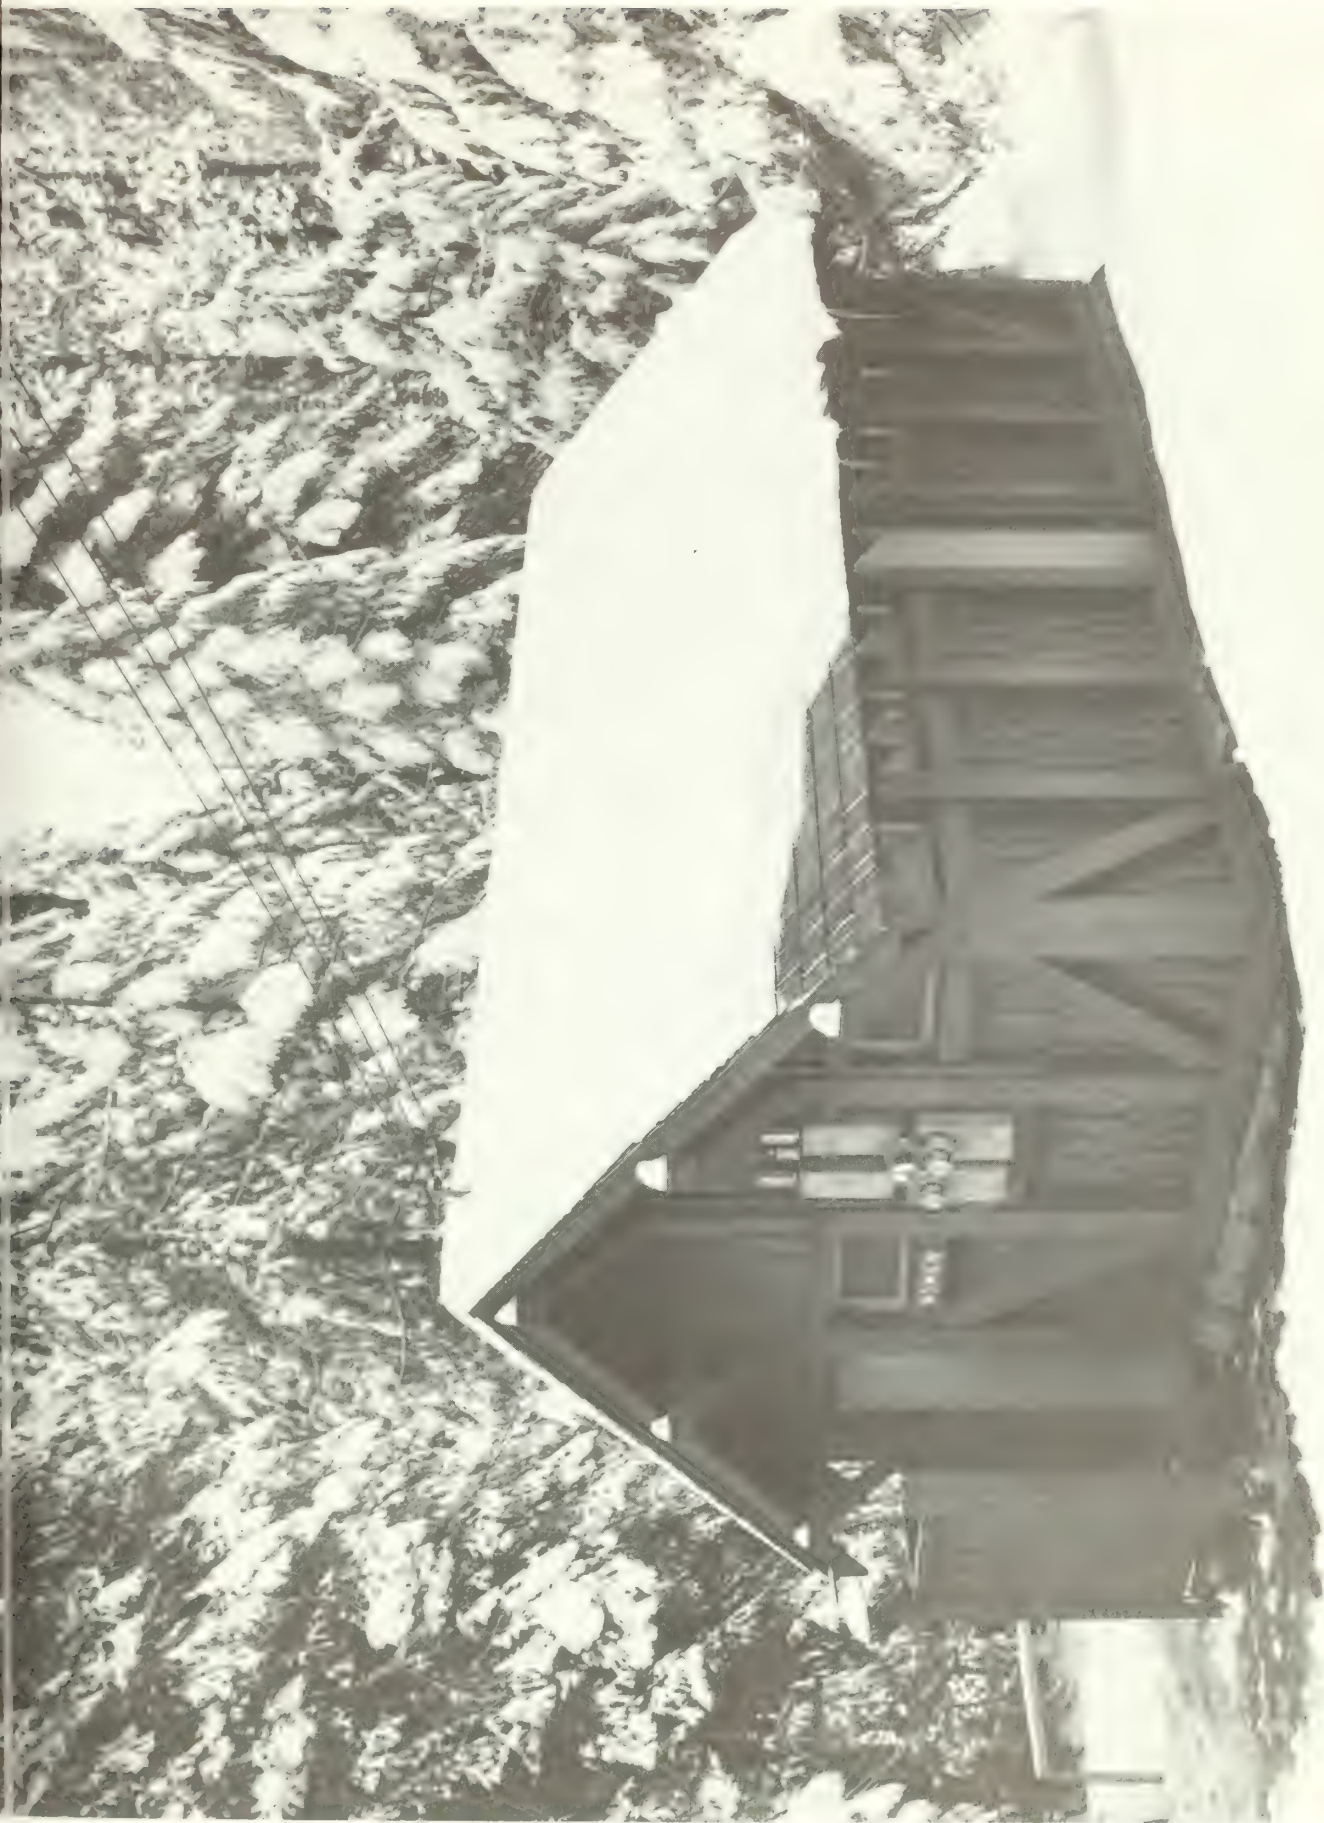
Figure 91. Comfort Station, View from Southeast (ca. 1983). The south facade is cluttered with electrical wiring and equipment which covers up one window. These accretions should be removed as part of the utility rehabilitation and distribution lines should be placed underground. The smooth asphalt walkway becomes slippery under these weather conditions. The walk could be made smaller, a new textured surface installed and additional handrailing considered. Note site grade in contact with wooden sill at this corner. Earth removal and installation of a more functional drainage swale is recommended. (HABS #CA 2148 C-3)

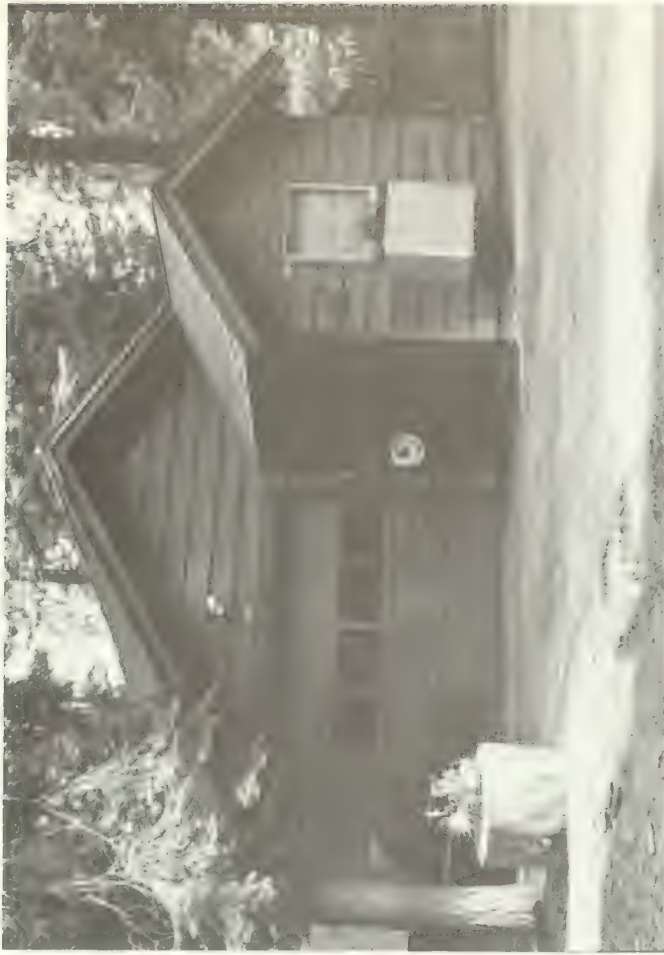
Figure 98. Ranger Residence Garage (5/86 and 10/86). At left, view from west; at right view of entry from south. Repainting, reroofing and installation of GFCI's are recommended at the garage.

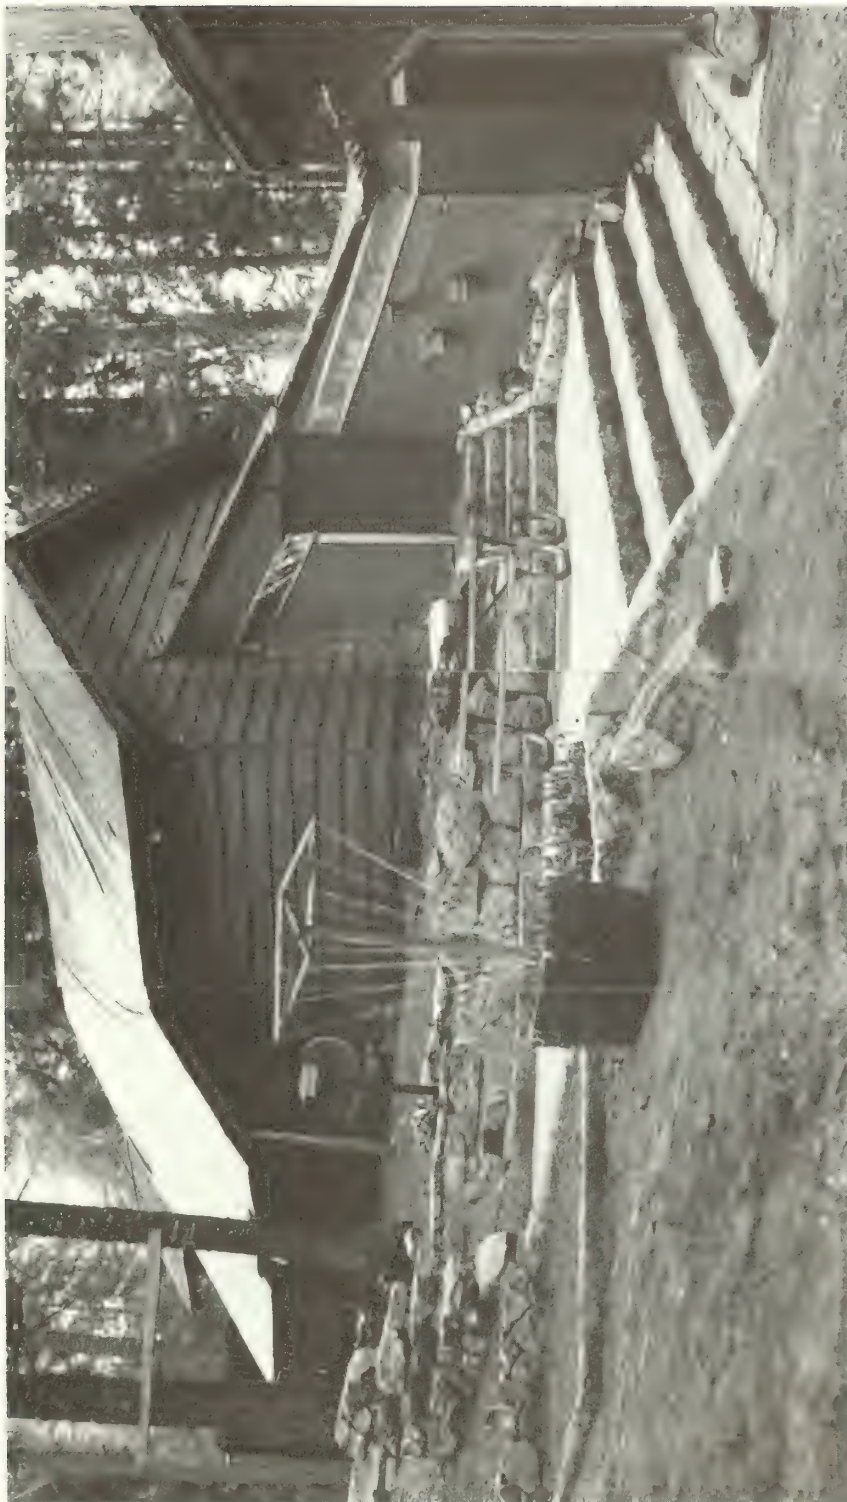
Figure 99. Ranger Residence/Garage, View from East (10/86). The date of the stone and concrete patio development is not known but it is of compatible material. The site drainage, however, is deficient as a result of both water from the patio and the gutter/downspout being concentrated at the southeast corner of the residence at right. This should be corrected. It's interesting and out of character that the siding and windows of the snow tunnel follow the slope of the land rather than being placed horizontally as is the siding of both the residence and garage.

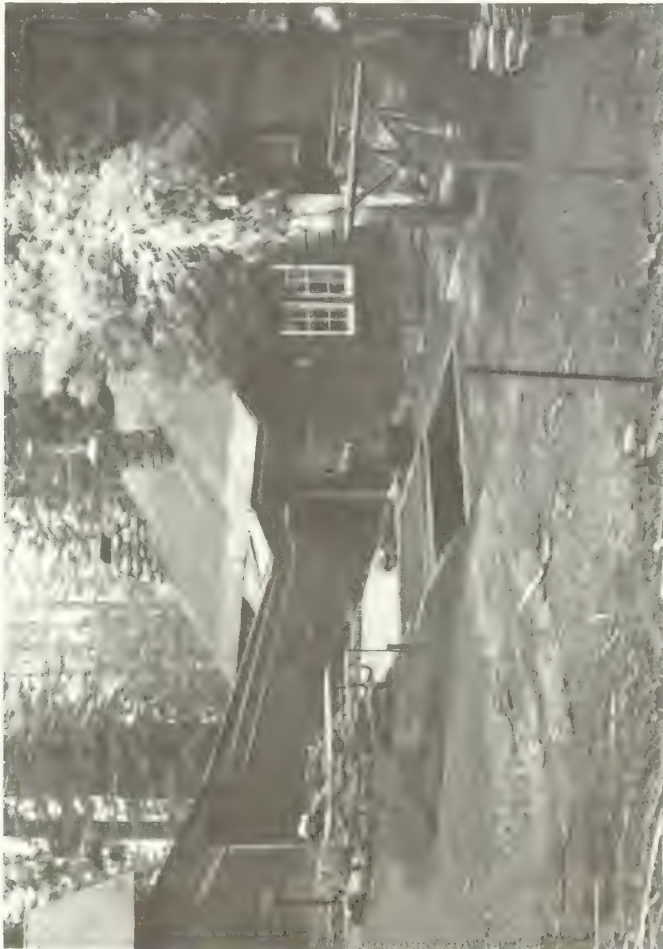
Figure 100 (left). Ranger Residence, View from East (10/86). The roof of the residence may require replacement prior to FY 94. The flue on the small chimney replaced a larger but more compatible flue in about 1984. The large chimney needs a spark arrestor/rain guard of more compatible design.

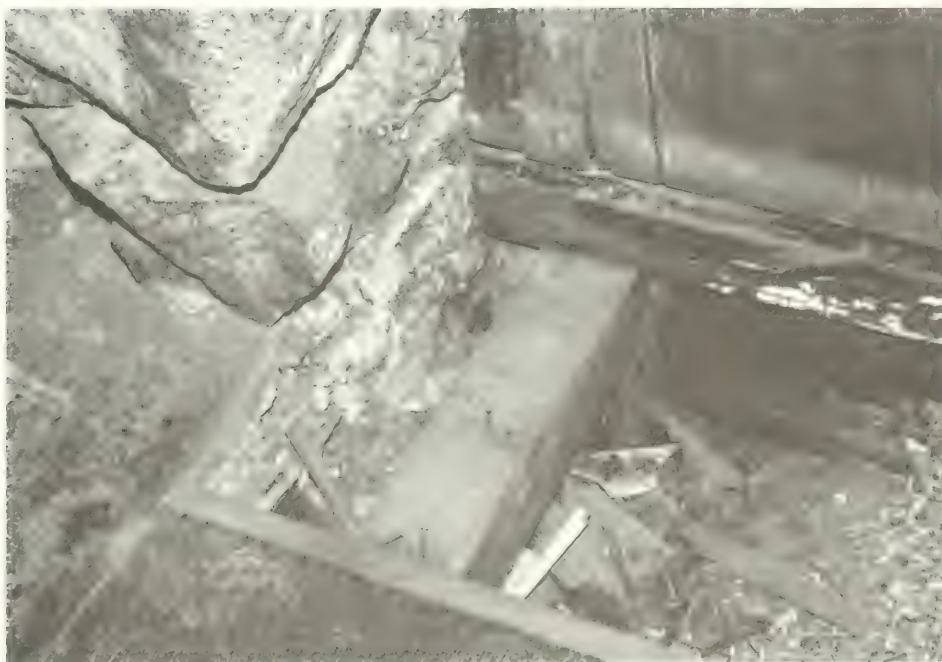
Figures A-15 and A-16. Market Crawl Space Vents (10/86). The above view is from inside the crawl space at the south end of the market (below room 100). This vent window is entirely blocked by earth on the exterior and partially obscured by debris and floor joist on the interior. The lower view is from the exterior of a vent on the market west wall. Most vents are reduced in effective size by the floor structural system, so it is especially important to eliminate additional, avoidable blockages. Also of note in the upper photograph is the decayed and fractured joist and beam, the result of excessive moisture and lack of adequate ventilation.
